**NEVADA COMMISSION FOR THE RECONSTRUCTION OF THE V&T RAILWAY  
("V&T Railway Commission")  
Agenda Report**

**Date Submitted:** June 20, 2024

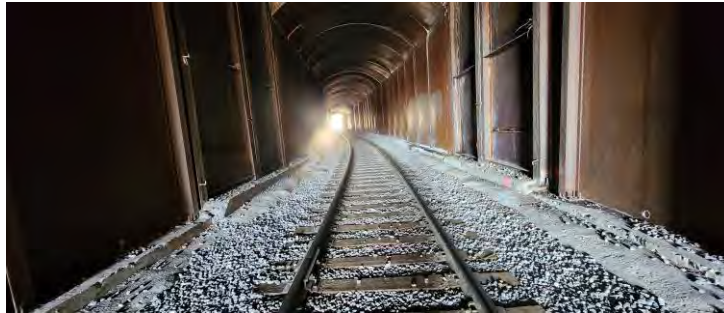
VCs Sta 856+90 to 857+36

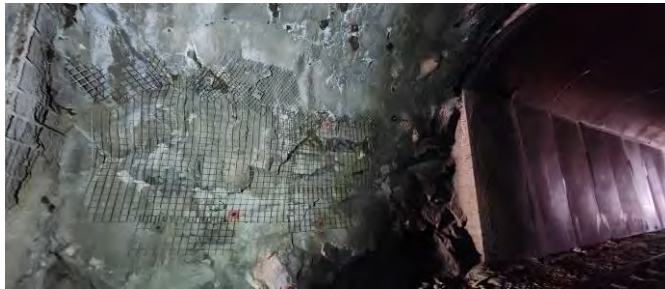
VCs 857+59 minor rock debris and seepage

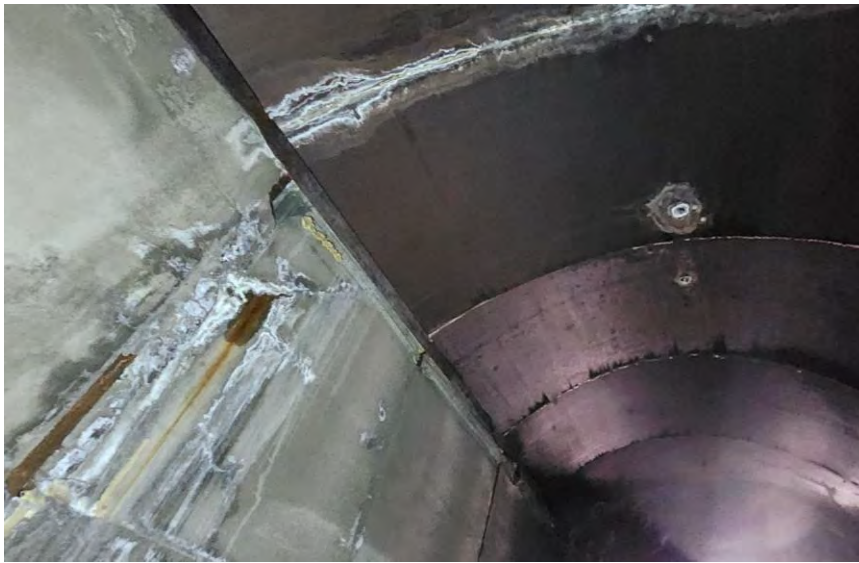
VCs Sta 858+16 Minor seepage

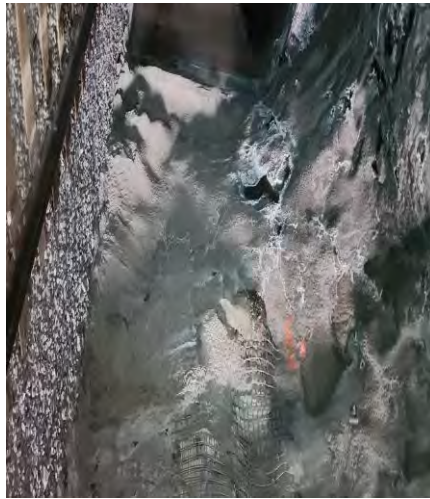
VCs Sta 858+70 additional seepage since previous inspection

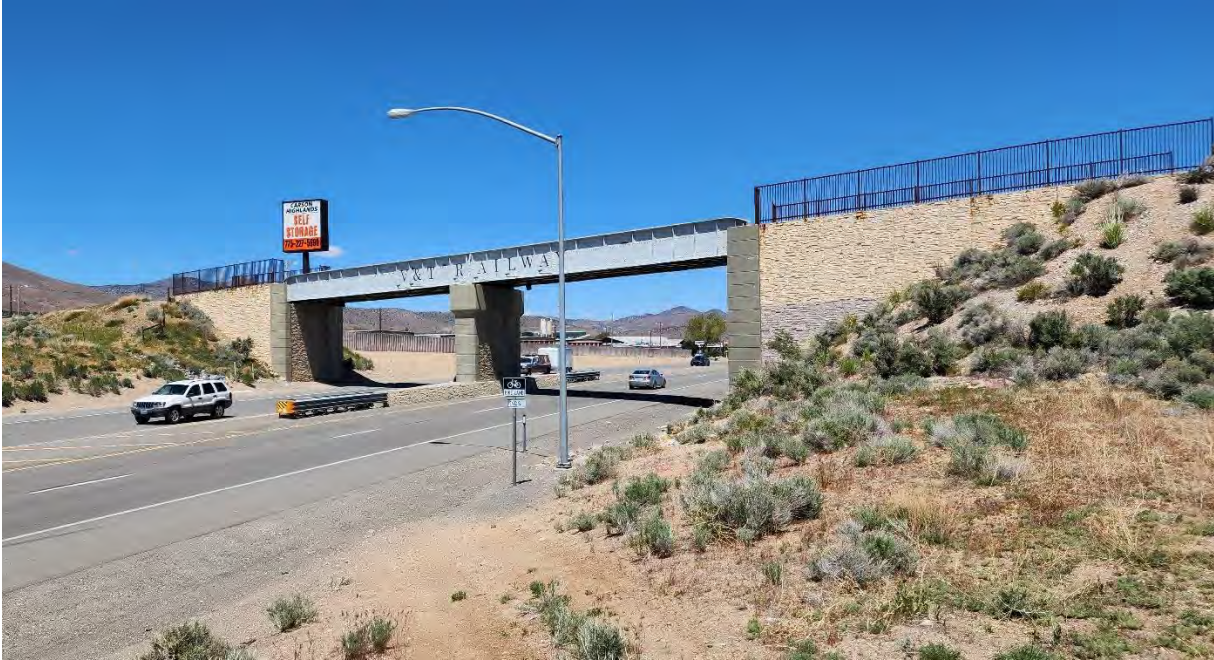
**VTRW Bridge Facing East along Eastbound Highway 50**

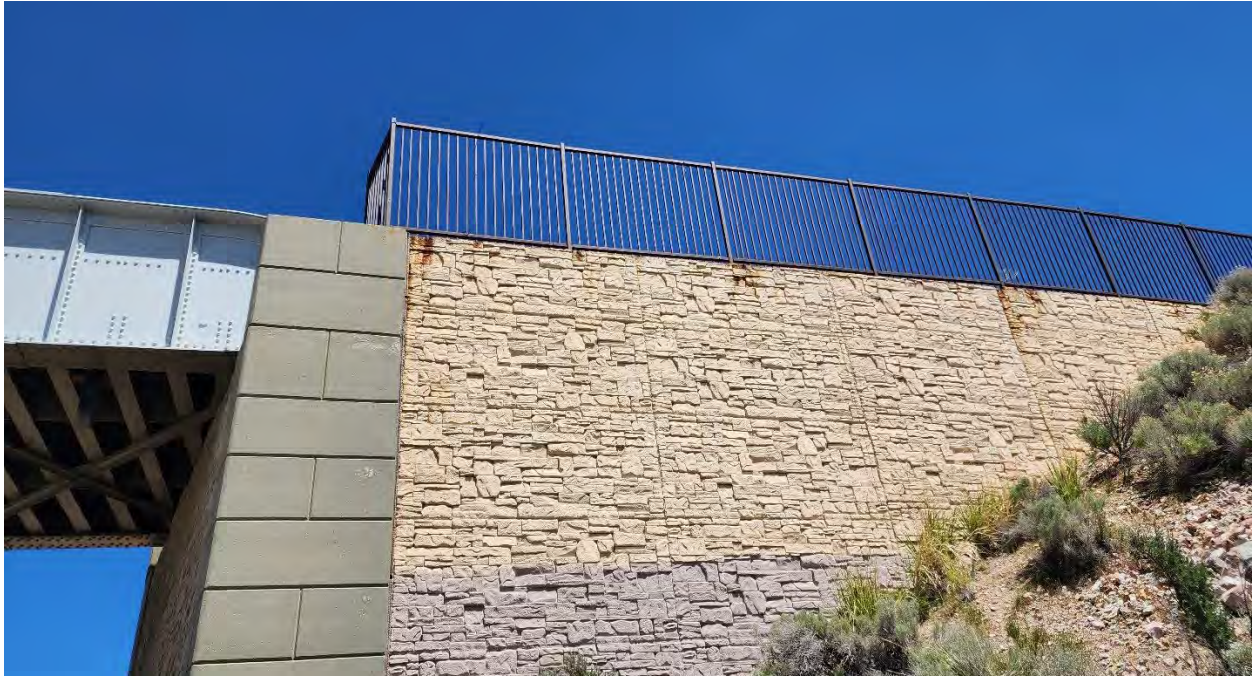
**West Wingwall @ South Abutment Facing East along Eastbound Highway 50**

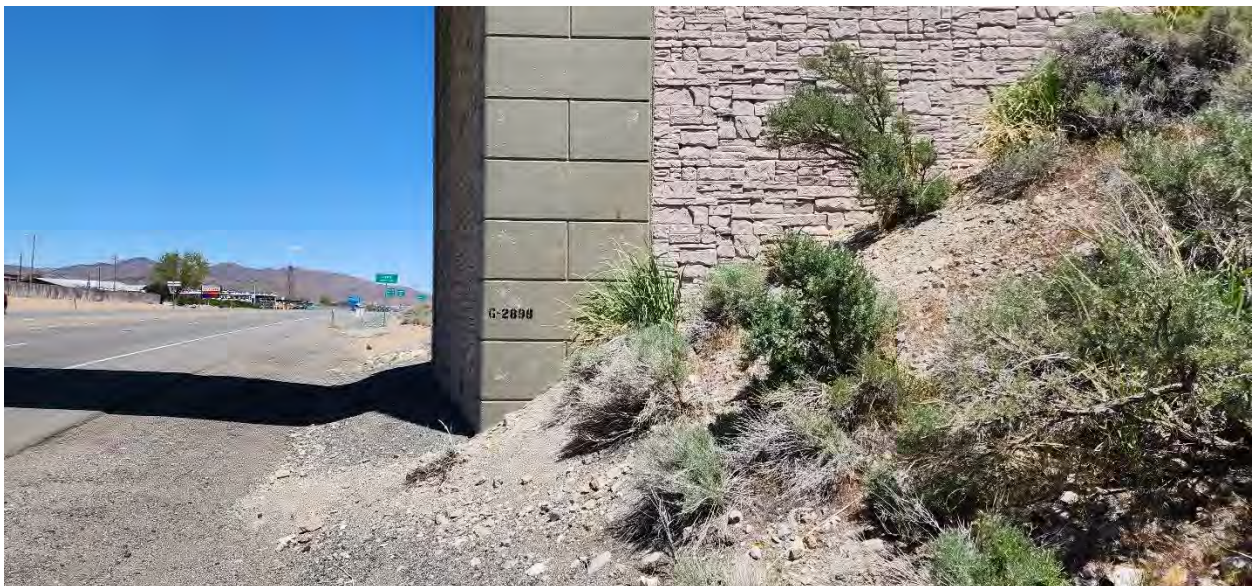
**South Abutment Facing East**

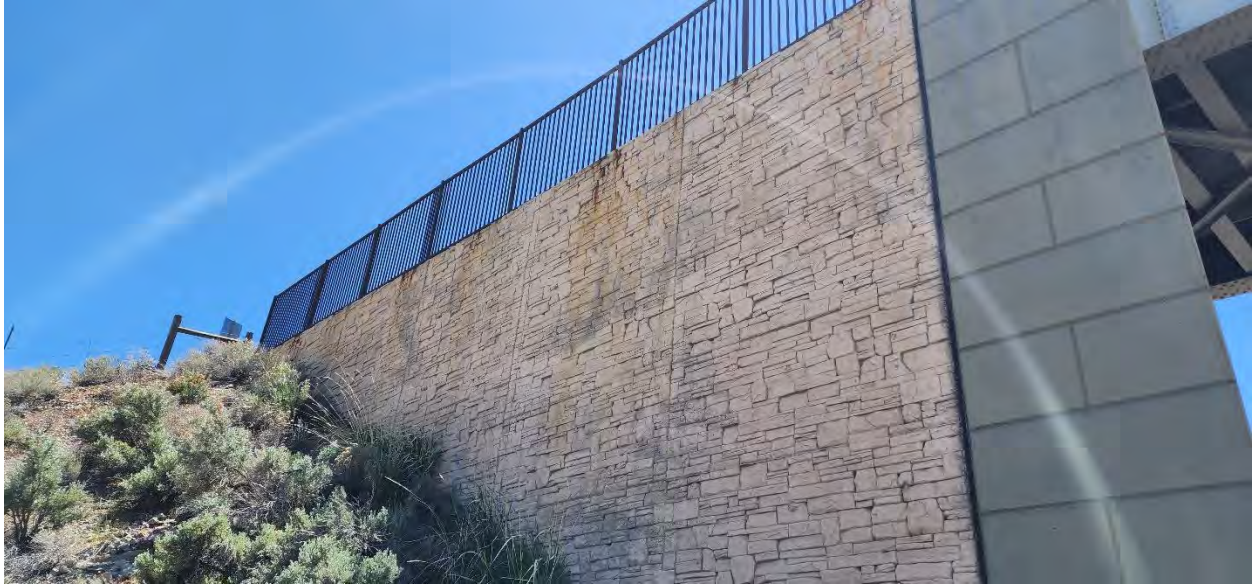
**South Abutment East Wingwall Facing West**

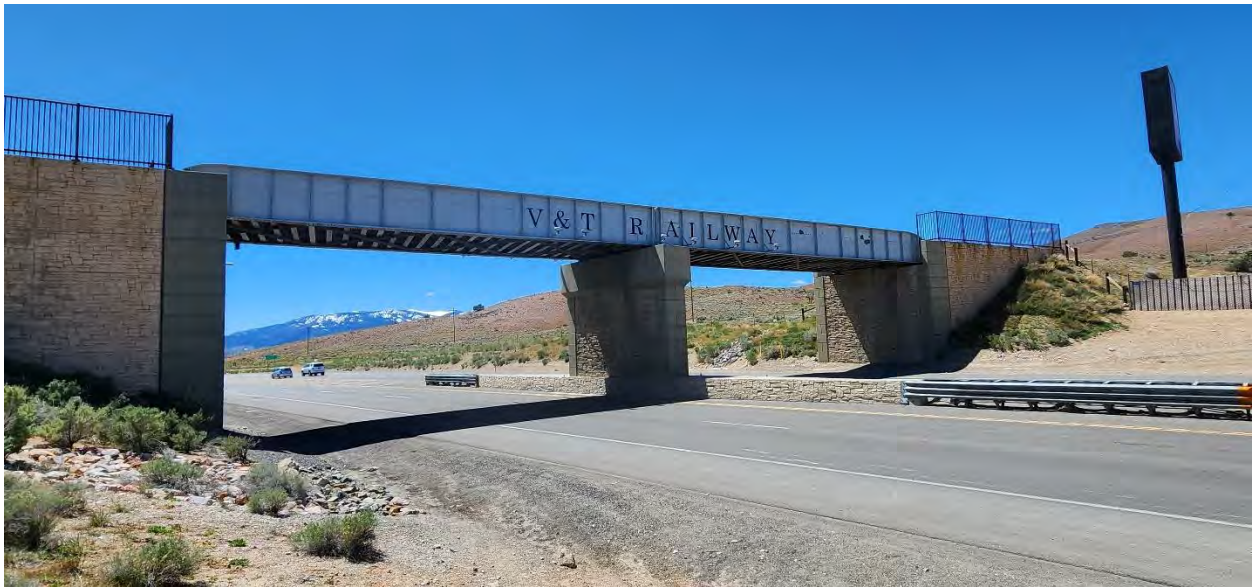
**South Abutment, Center Pier & North Abutment Facing West**

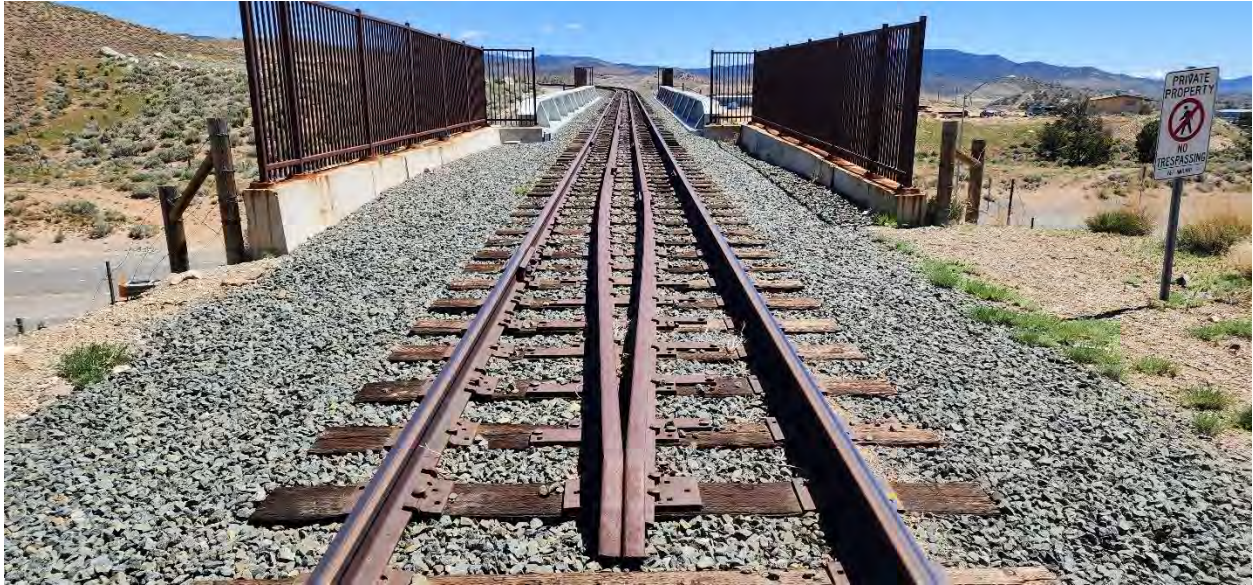
**Center of Track Facing Southeast/Down Station towards Carson City Depot**

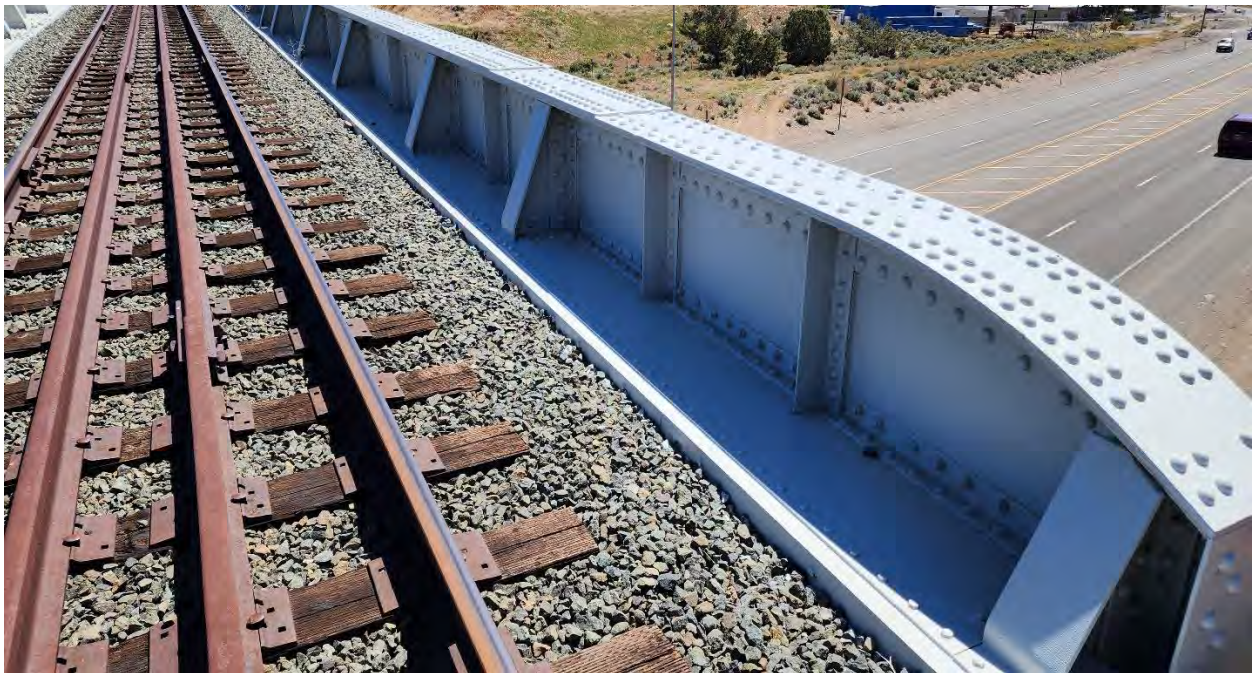
**Knee Brace and Ballast Tub Plate on Left Side of Bridge @ North Span, Facing Southwest**

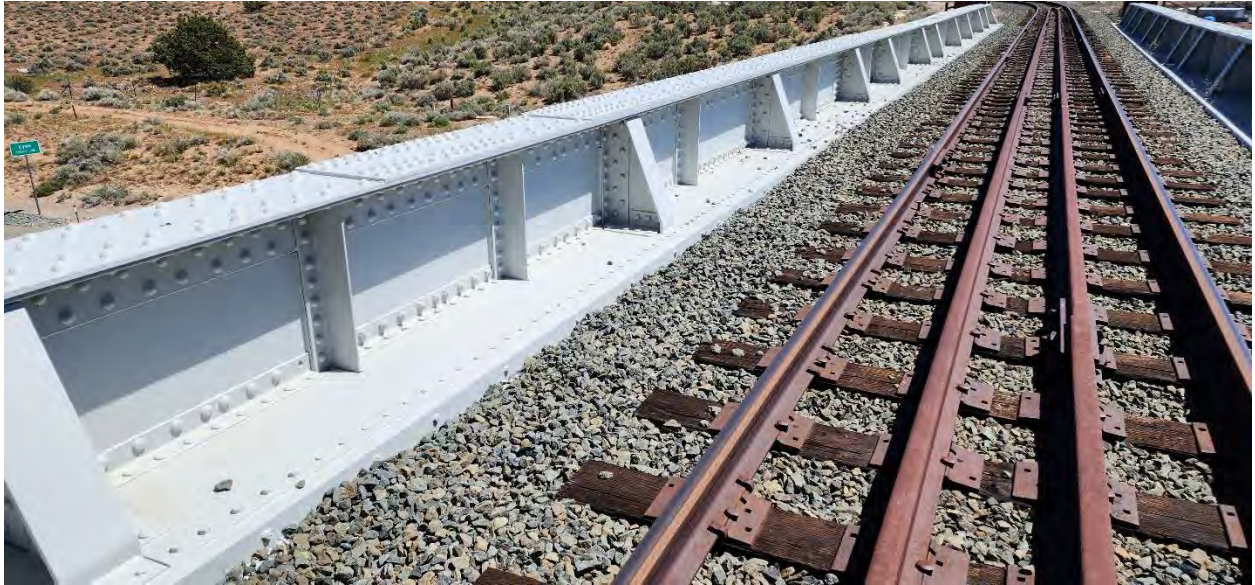
**Main Girder and Ballast Tub Plate @ Left Side of Bridge Facing Northwest**

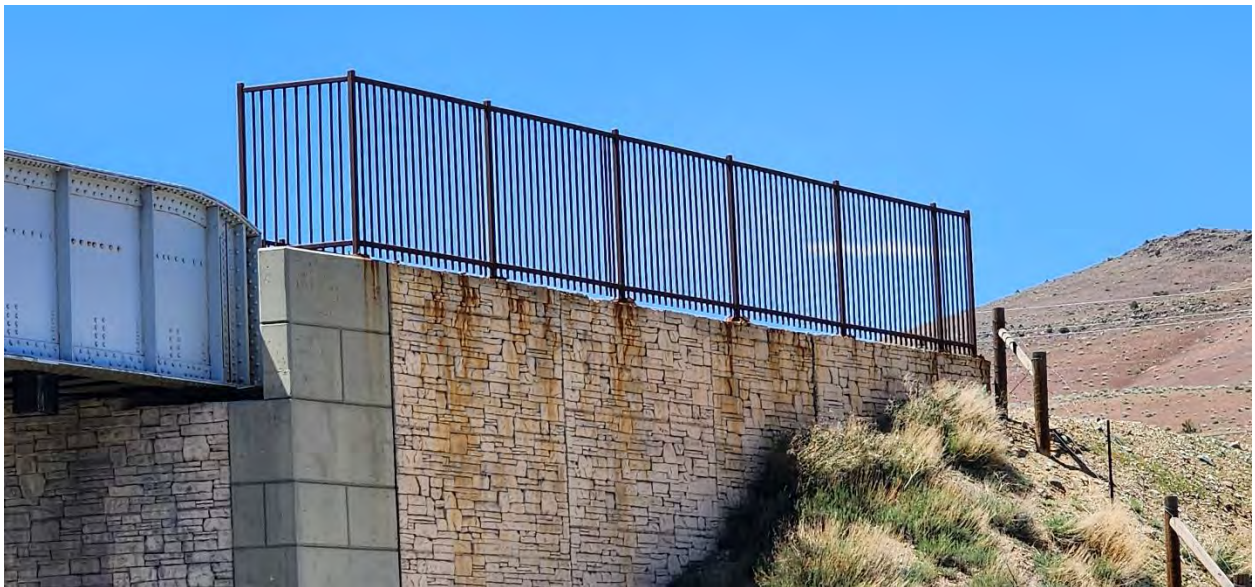
**North Abutment East Wingwall Facing Northwest**

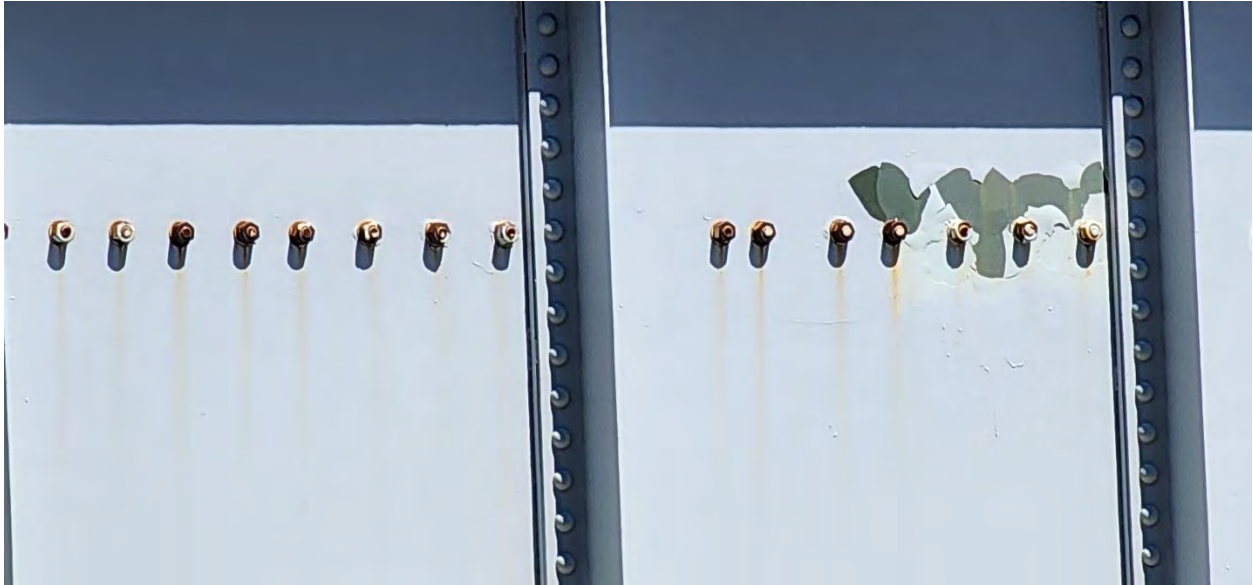
**Main Girder At North span Facing East**  
**Rust forming and Paint Peeling on fasteners and panels**

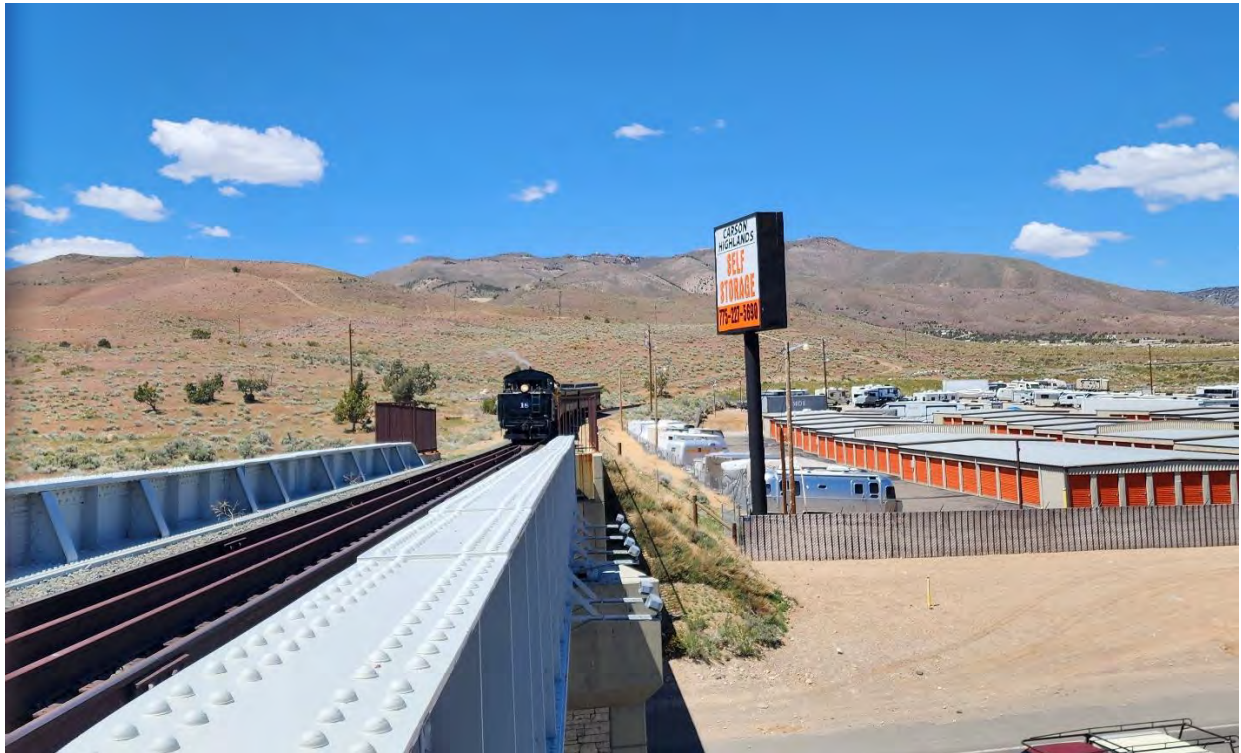
**Train approaching Bridge from North**  
**No deflection noted from live load crossing**

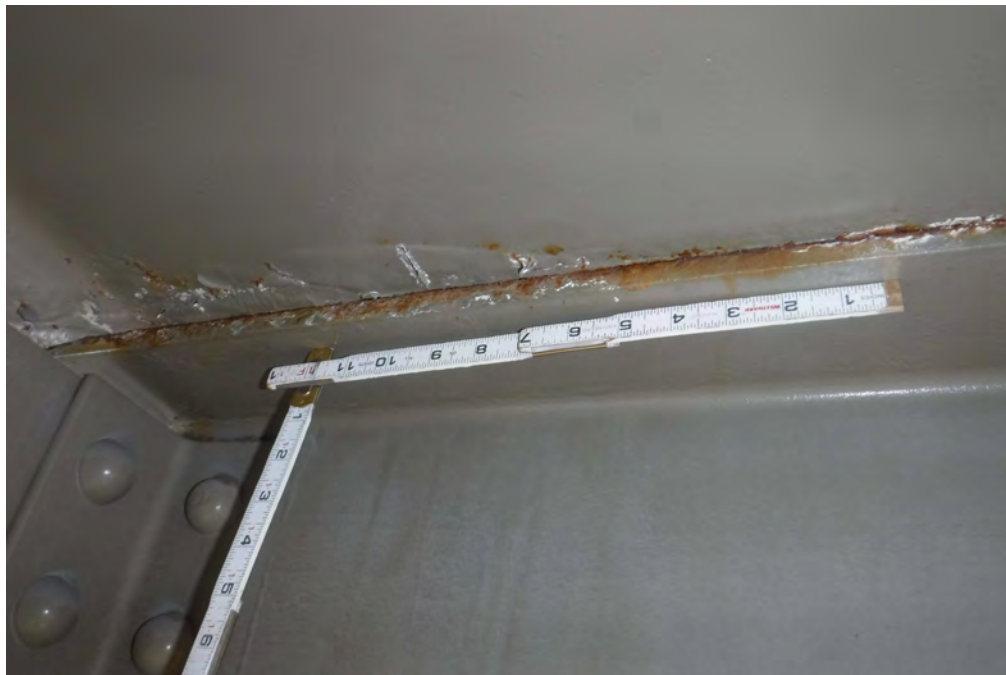
Photo 5: Typical failed coating and corrosion of the girder and bearings

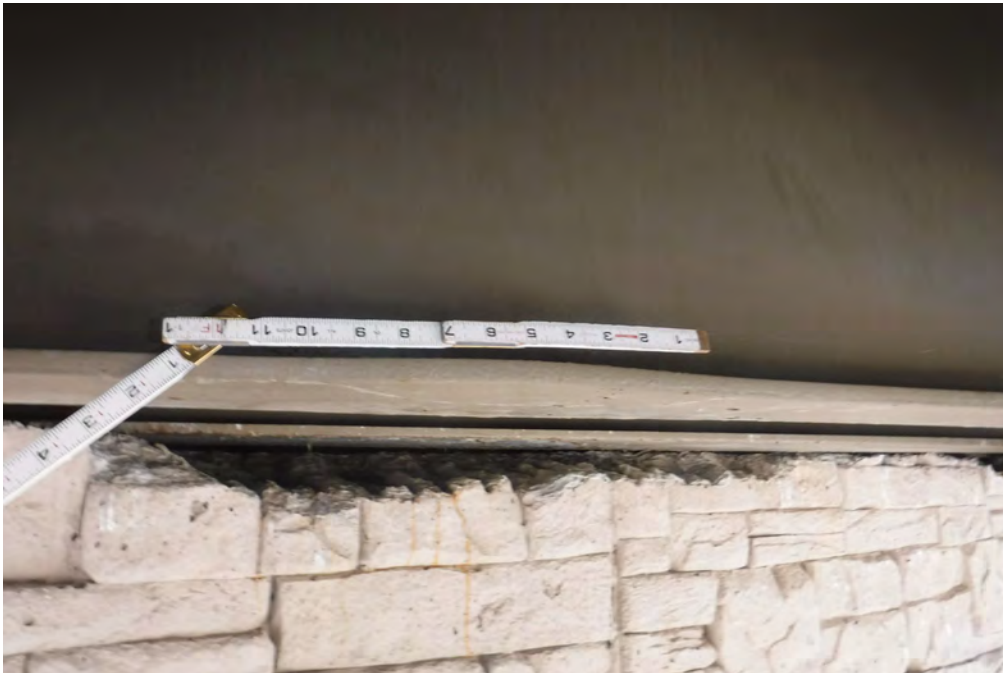
Photo 7: Typical failing steel protective coating and corrosion on floor beams and diaphragms
